## **Media Converters**

## 10/100/1000 Base TX to 1000 Base FX

### Overview

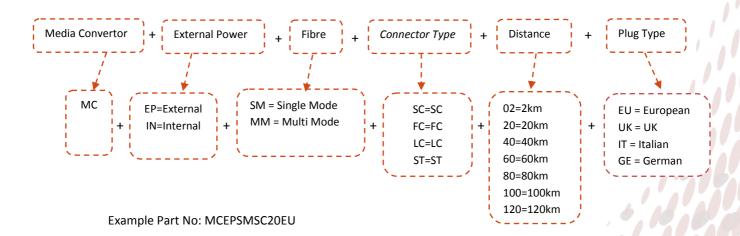
## PART NUMBER CONFIGURATION

Please use the below part number description to obtain the exact part number as required.
